RESEARCH OF SURFACE CONDITION OF THE RAILS ROLLING ON SECTIONS OF HIGH-SPEED AND HIGH-SPEED TRAIN TRAFFIC

Абдуалиев Э.Б.¹
Abdualiyeв E.B.¹

¹ – Tashkent Institute of Railway Engineers (Tashkent, Uzbekistan)

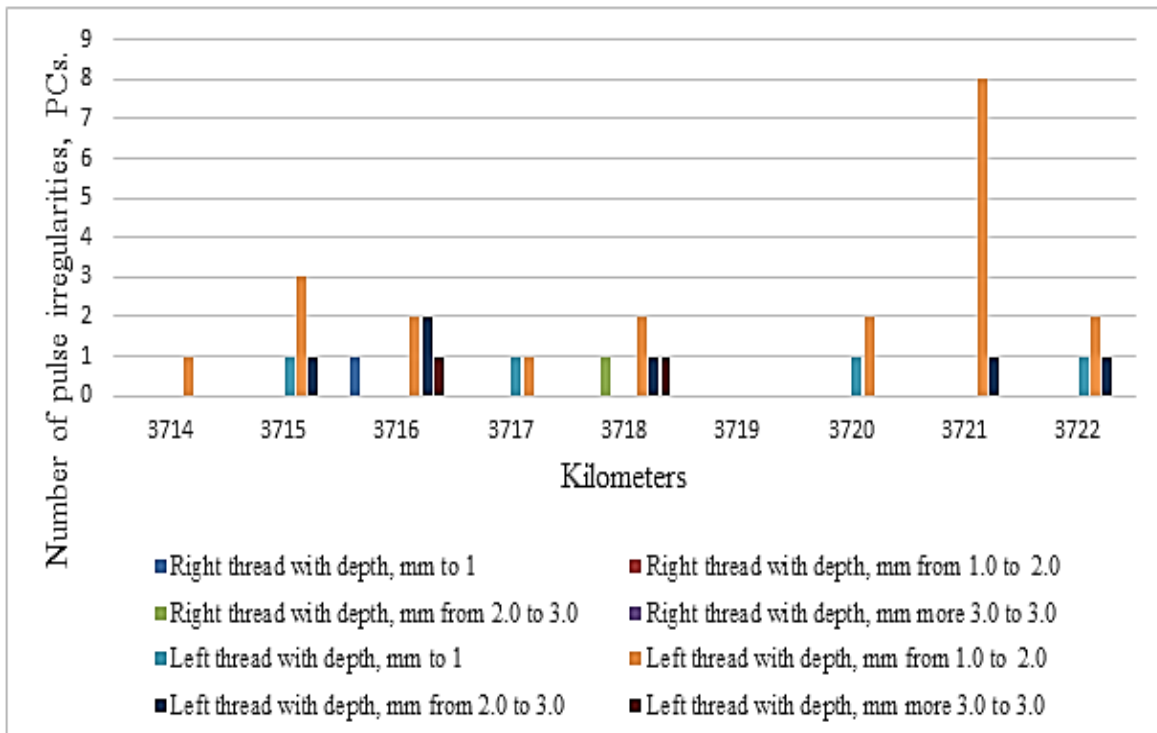
For rice. 1, 2 and 3 presents a graphical interpretation of the number of pulse irregularities on the rails of the experimental sections. This it is possible to state that on the left rail thread on all experimental sites the number of impulse roughnesses is more than on the right rail thread.

Figure 1. The number of pulse irregularities in the experimental site number 1.

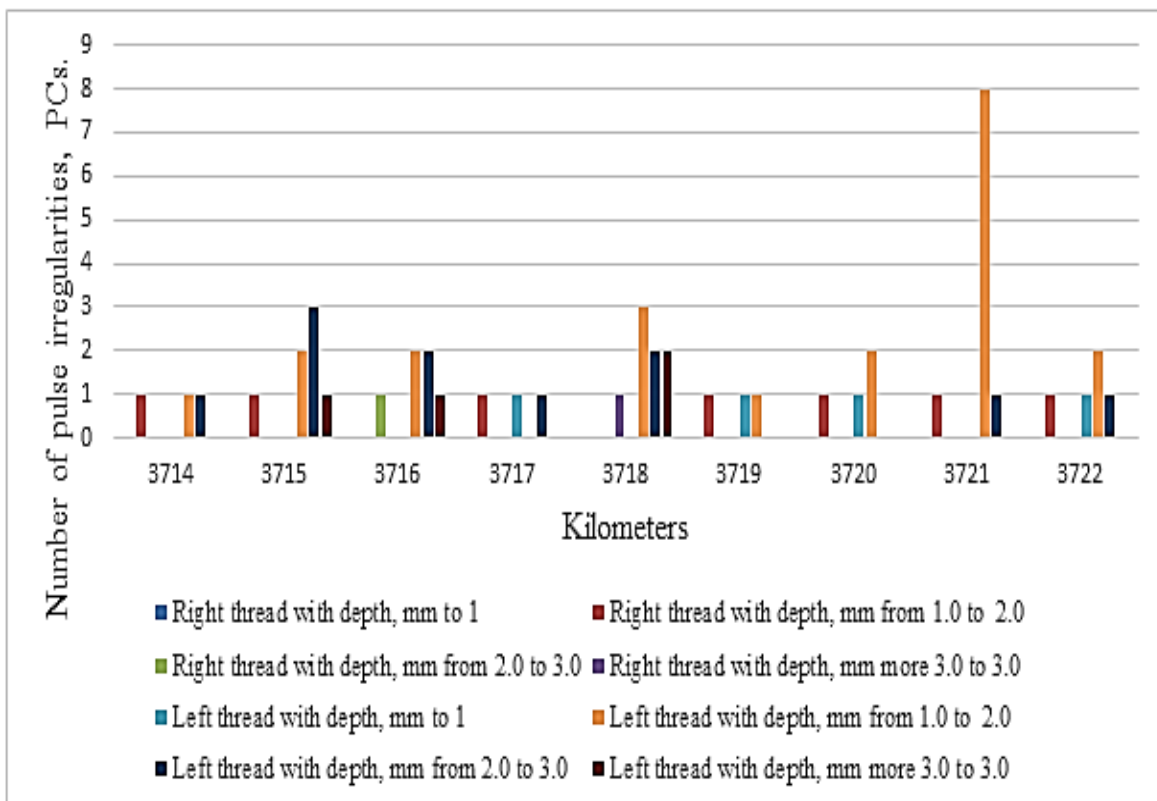
Figure 2. The number of pulse irregularities in the experimental site number 1.

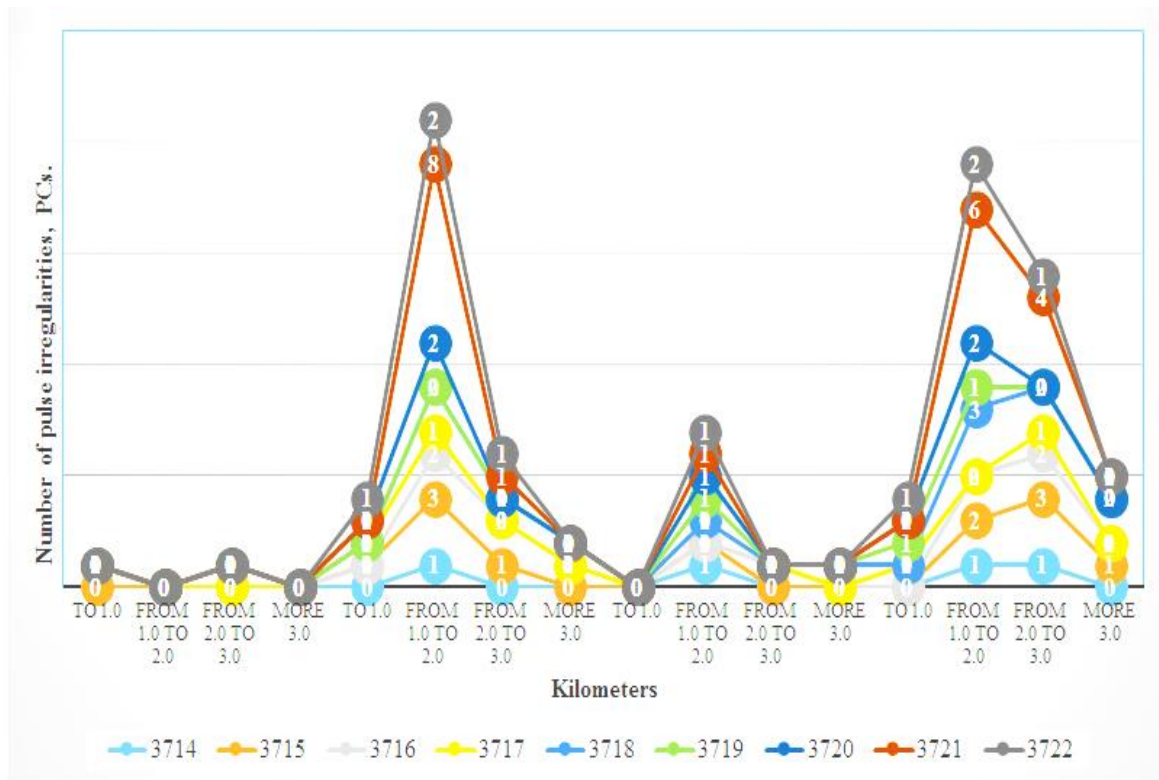
Figure 3. The number of pulse irregularities in the experimental site number 1.
