DIAGNOSIS AND TREATMENT METHOD OF IMPACTED TEETH ON THE UPPER JAW

Mikhail A. Postnikov
Samara State Medical University

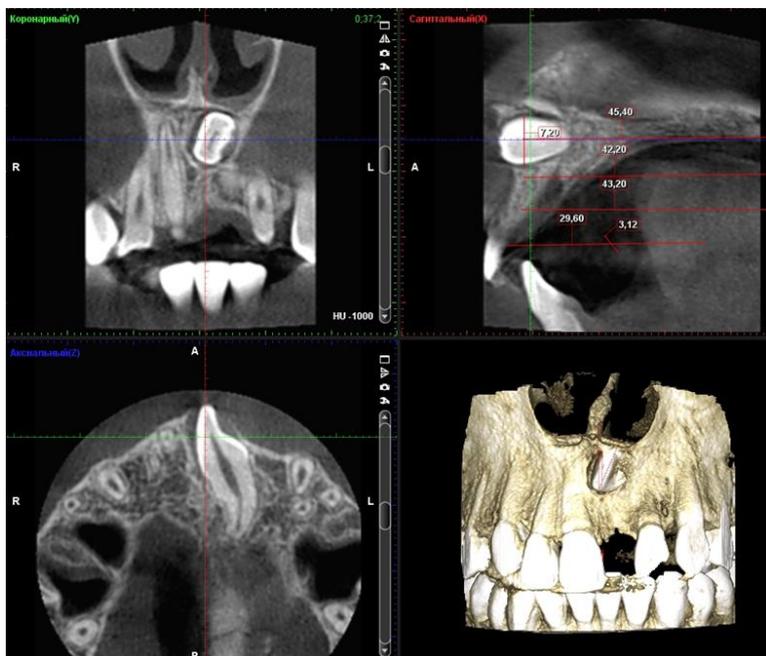
Fig.1. Determination of three levels of the impacted teeth location (incisors and canines of the upper jaw) on the CBCT of patient A., 14 years old (III level of tooth 2.1 location)

drawn on the computed tomography of the patient: one through the points Spina nasalis anterior (Sna) and Spina nasalis posterior (Snp), and the other through the apical base of the upper jaw. The vertical distance between these lines is divided into three equal parts and horizontal lines are drawn through the resulting points. The first level of the tooth is located between the two lower lines, the third - between the two upper lines, the second - in the middle (Fig. 1).

To determine the level of location of the impacted tooth on the CBCT, an image in the sagittal plane was used. It was found that it is advisable to distinguish precisely three levels of location of the impacted tooth, since the vertical distances between the horizontal lines correspond to the size of crown of the impacted tooth. We determine the level of location of the impacted tooth by the zone, where tooth's crown is.

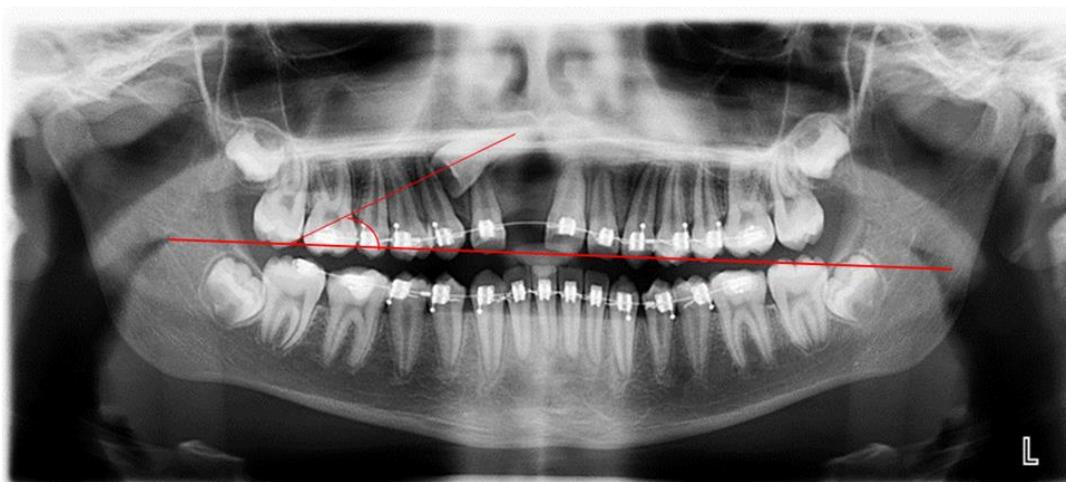
Fig.3. Location of the impacted tooth 1.1 of patient O., 13 years old, before orthodontic treatment (angle of inclination of tooth is 30 °)

An X-ray examination of the patient included orthopantomography, telereöntgenography of head in lateral projection, using Dolphin Imaging software to analyze cephalometric radiographs and cone beam computed tomography of the tooth 1.1. The study of orthopantomogram was carried out according to the method of Yu.I. Zhigurt. The location level of the impacted tooth 1.1 was determined, as well as the angle of inclination of its longitudinal axis (Fig. 3). We noted three levels of the impacted teeth location in the sagittal plane on CT scan of the upper jaw according to our method. The 3rd level of the impacted tooth 1.1 location was determined (Fig. 4).

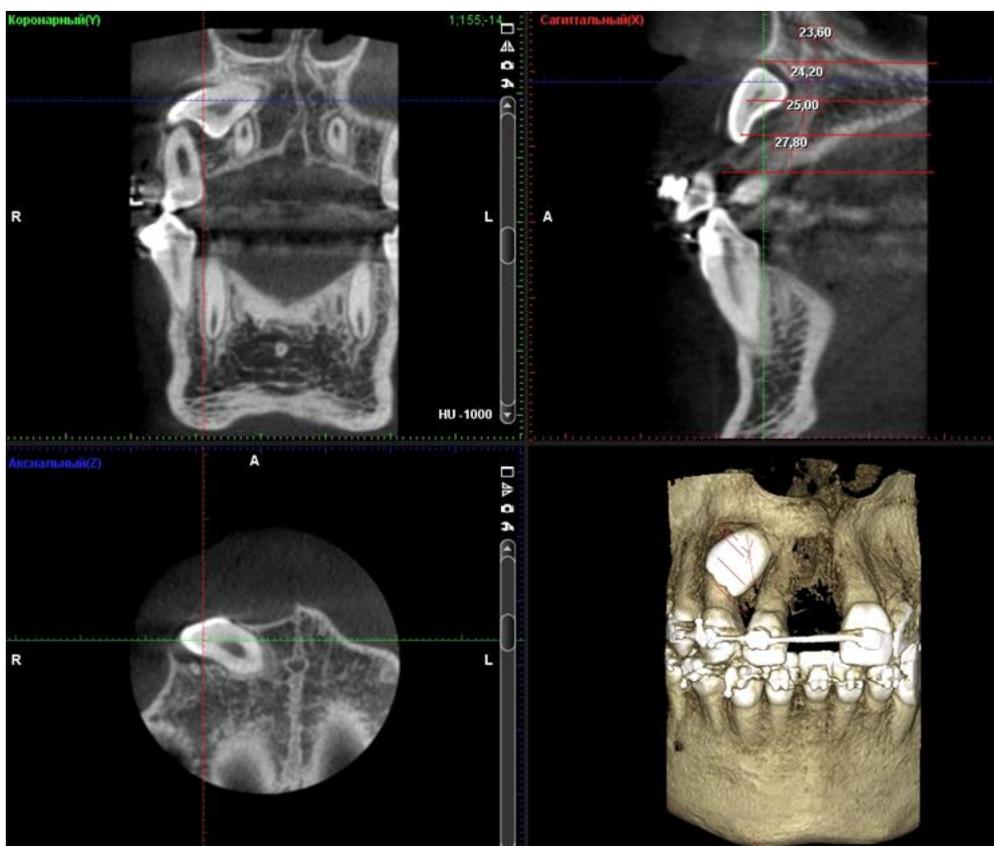
Fig.4. Location of the impacted tooth 1.1 of patient O., 13 years old, in three projections before orthodontic treatment (3rd level of the tooth 1.1 location)

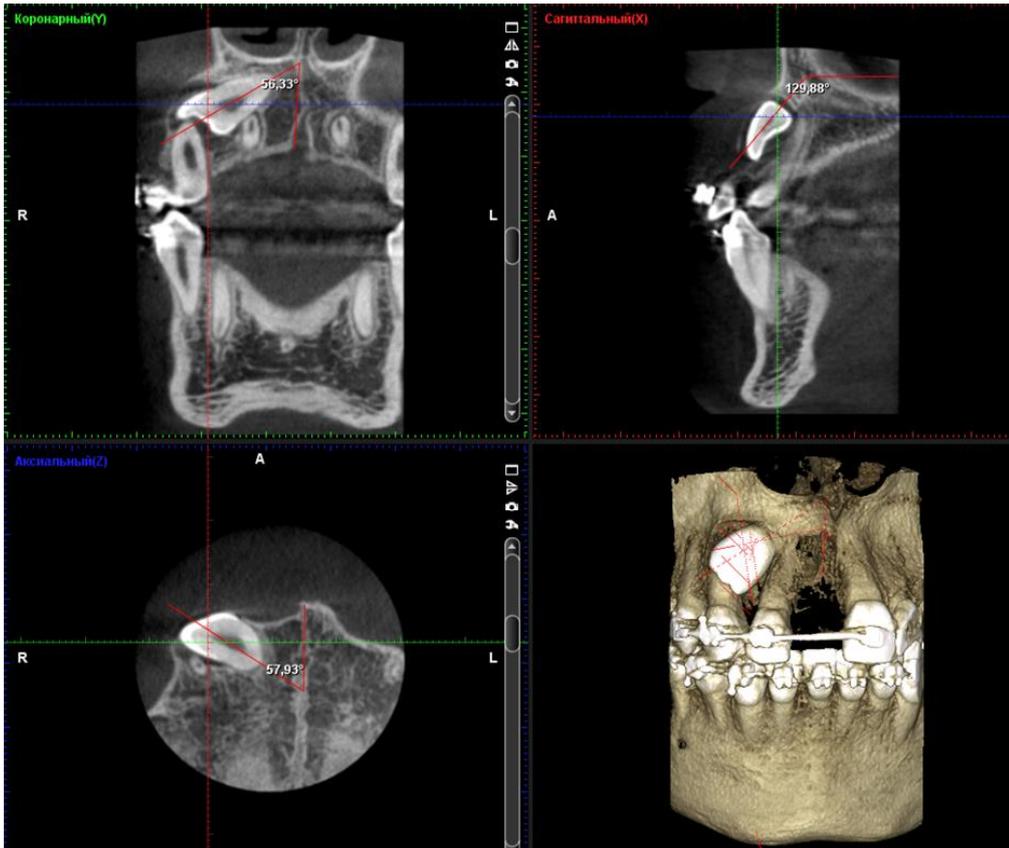
Fig.5. Determination of angles of the impacted tooth 1.1 inclination: in the coronary plane - 56.33 °, in the sagittal plane - 129.88 °, in the axial plane - 57.93 °.

Then, we measured angles of inclination of the impacted tooth 1.1 in three mutually perpendicular planes (Fig. 5).

As a result of measurements, we obtained the following angles: in the coronary plane - 56.33 °, in the sagittal plane - 129.88 °, in the axial plane - 57.93 °. Then, we compared the obtained data with the data in Table 1. Angle of inclination of the impacted tooth 1.1: in the coronary plane - II degree; in the sagittal plane - III degree; in the axial plane - II degree.

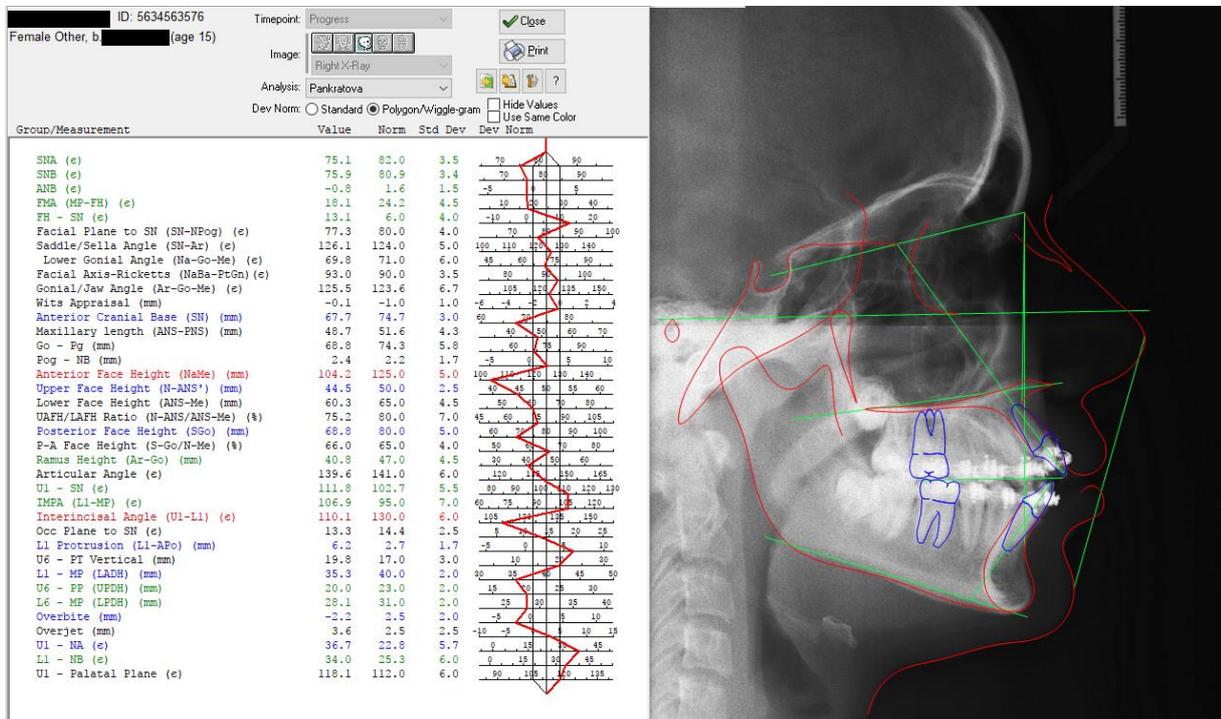
Fig.6. Cephalometric x-ray image of head in lateral projection of the patient O., 15 years old with analysis using Dolphin Imaging software (USA) at the stage of orthodontic treatment.

Patient underwent comprehensive surgical and orthodontic treatment. We made one more cephalometric x-ray at the stage of orthodontic treatment with its analysis in Dolphin Imaging (Fig. 6). X-ray examination was performed again after the orthodontic treatment (Fig. 7, 8). Comprehensive treatment of patient O. lasted 2 years and 5 months.

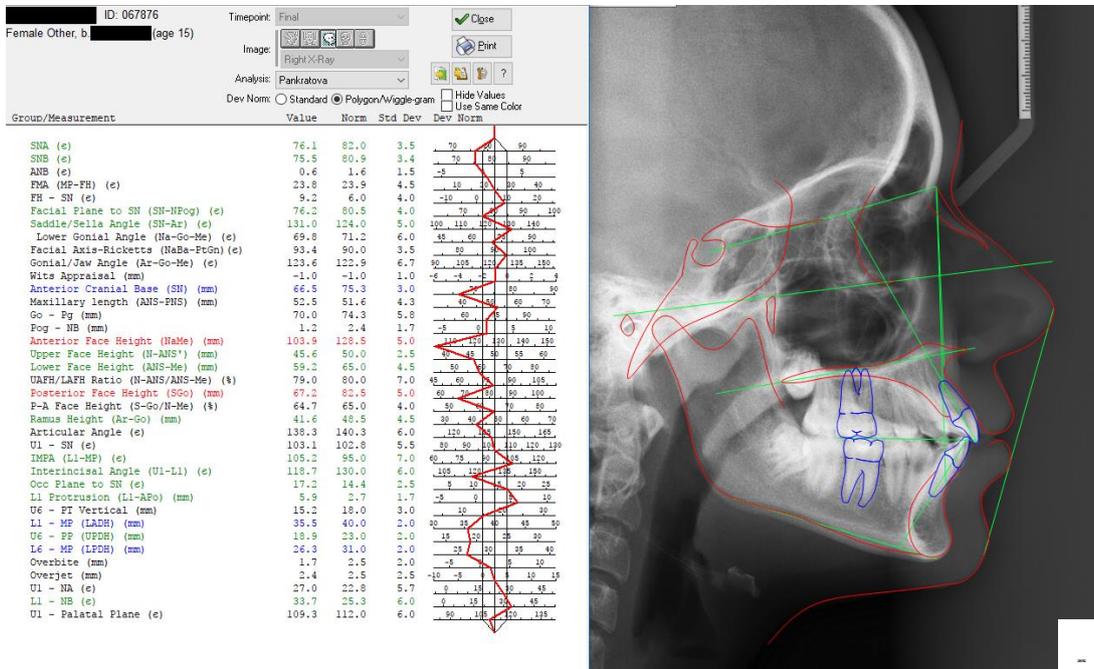
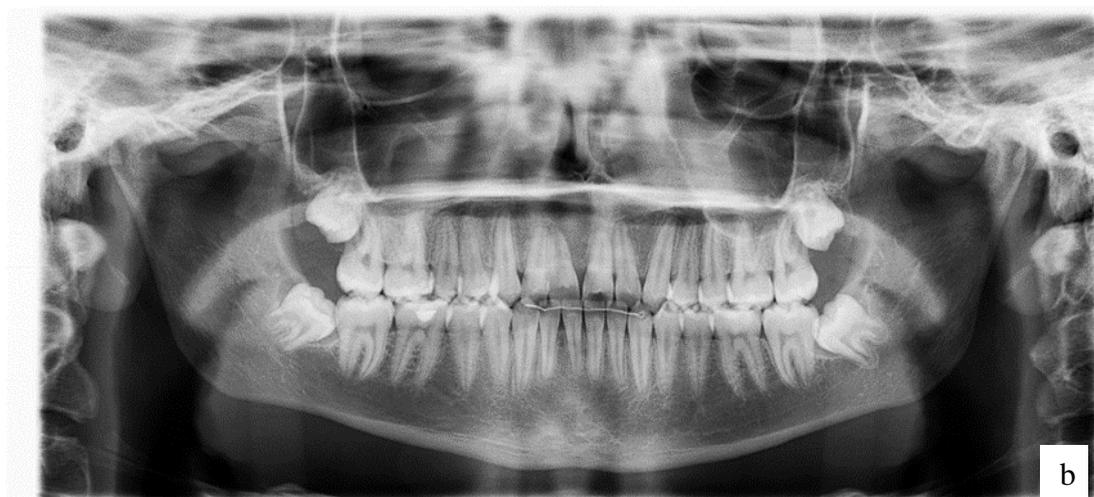
Fig.8. Cephalometric x-ray image of head in lateral projection of the patient O., 15 years old with analysis using Dolphin Imaging software (USA) after orthodontic treatment – a; location of the impacted tooth 1.1 after orthodontic treatment – b.
