## DIAGNOSIS AND TREATMENT METHOD OF IMPACTED TEETH ON THE UPPER JAW

Postnikov, Mikhail A.; Trunin, Dmitriy A.; Kirilin, Maksim M.; and Stepanov, Grigoriy V. (2019) "DIAGNOSIS AND TREATMENT METHOD OF IMPACTED TEETH ON THE UPPER JAW," *Central Asian Journal of Medicine*: Vol. 2019 : Iss. 4 , Article 12.

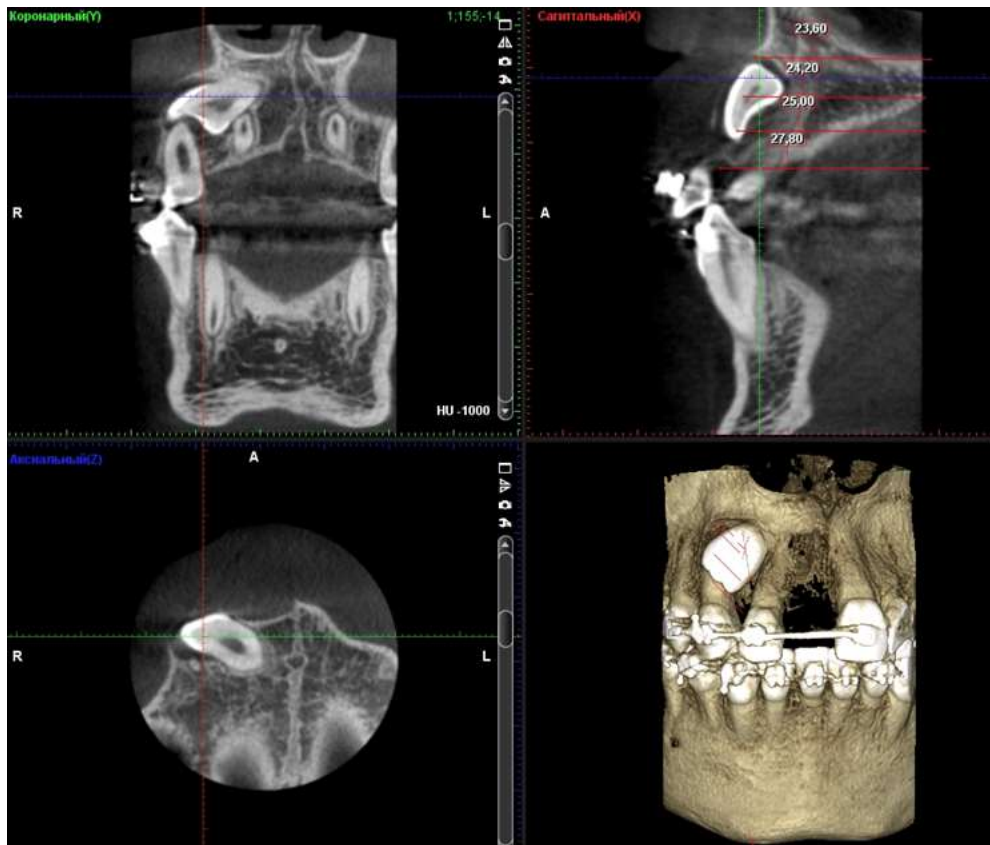
**Fig.4.** Location of the impacted tooth 1.1 of patient O., 13 years old, in three projections before orthodontic treatment (3rd level of the tooth 1.1 location)

An X-ray examination of the patient included orthopantomography, telereöntgenography of head in lateral projection, using Dolphin Imaging software to analyze cephalometric radiographs and cone beam computed tomography of the tooth 1.1. The study of orthopantomogram was carried out according to the method of Yu.I. Zhigurt. The location level of the impacted tooth 1.1 was determined, as well as the angle of inclination of its longitudinal axis (Fig. 3). We noted three levels of the impacted teeth location in the sagittal plane on CT scan of the upper jaw according to our method. The 3<sup>rd</sup> level of the impacted tooth 1.1 location was determined (Fig. 4).

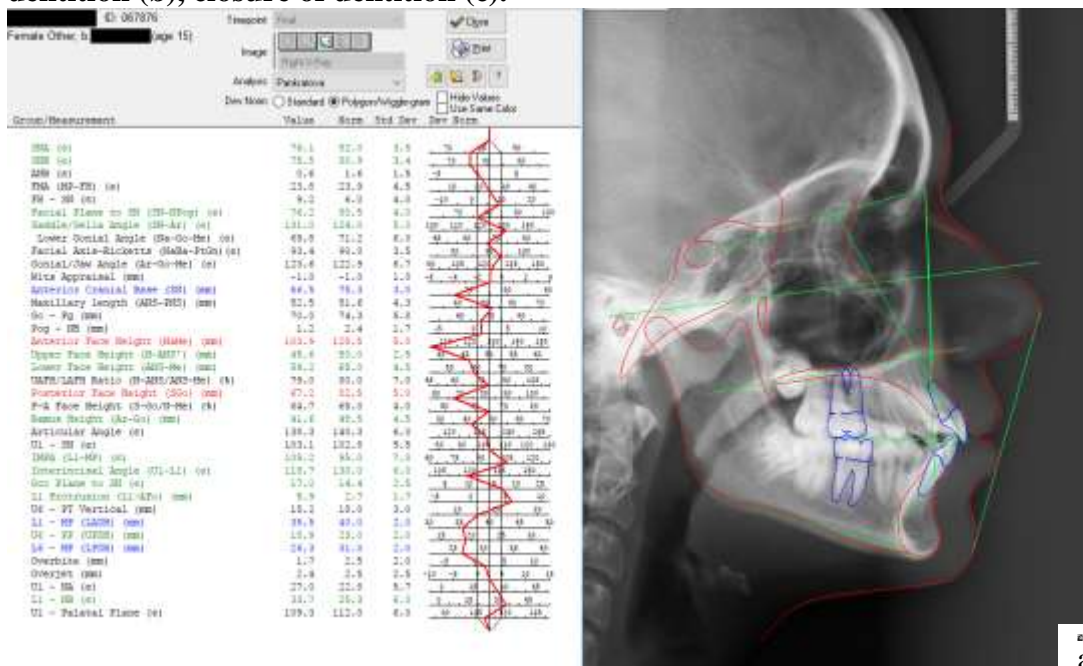
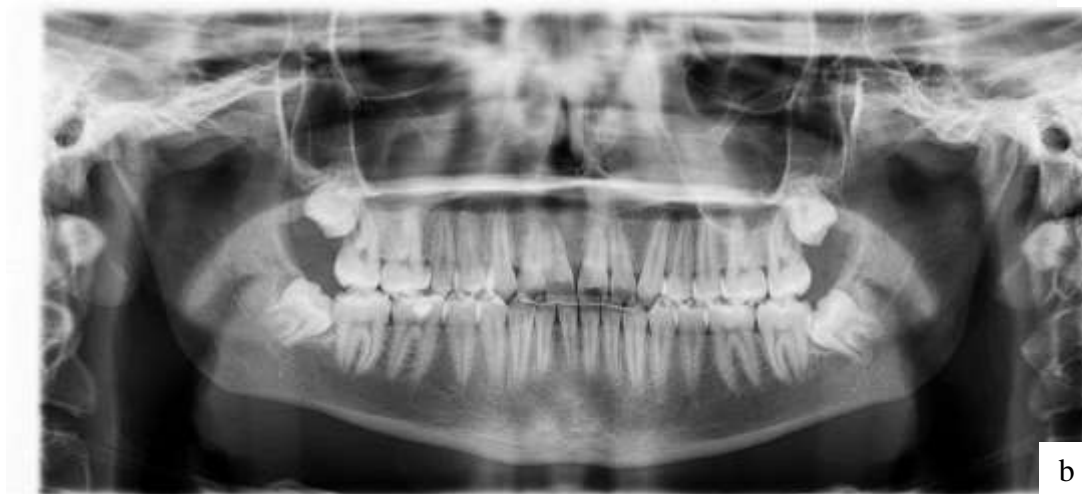
**Fig.8. Cephalometric x-ray image of head in lateral projection of the patient O., 15 years old with analysis using Dolphin Imaging software (USA) after orthodontic treatment – a; location of the impacted tooth 1.1 after orthodontic treatment – b.**

Patient underwent comprehensive surgical and orthodontic treatment. We made one more cephalometric x-ray at the stage of orthodontic treatment with its analysis in Dolphin Imaging (Fig. 6). X-ray examination was performed again after the orthodontic treatment (Fig. 7, 8). Comprehensive treatment of patient O. lasted 2 years and 5 months.
